TEST REPORT

No. : XMCCM150100122

Sample Name : FIRE RATE DOWNLIGHT
Type No. : 1) FR1137W; 2) FR1175W; 3) FR1185W; 4) FR1193W;
5) FR1001W; 6) FR1003W; 7) FR1009W; 8) FR1011W
Test Item : Fire Resistance Test
Test Requested : BS 476-20:1987 Incorporating Amendment No.1.Fire tests on building materials and structures-Part 20:Method for determination of the fire resistance of elements of construction(general principles)
BS 476-21:1987 Fire tests on building materials and structures-Part 21: Methods for determination of the fire resistance of loadbearing elements of construction
Date of Receipt : Jan 28, 2015
Test Period : Jan 28, 2015 to Feb.12, 2015
Test Results : For further details, please refer to the following page(s)

To determine the fire resistance of a timber floor assembly protected by a plasterboard ceiling designed to provide 90 minutes fire resistance, incorporating six downlight fittings, when tested in accordance with Clause 7 of BS 476-21:1987 "Fire tests on building materials and structures – Part 21: Methods for determination of the fire resistance of loadbearing elements of construction".

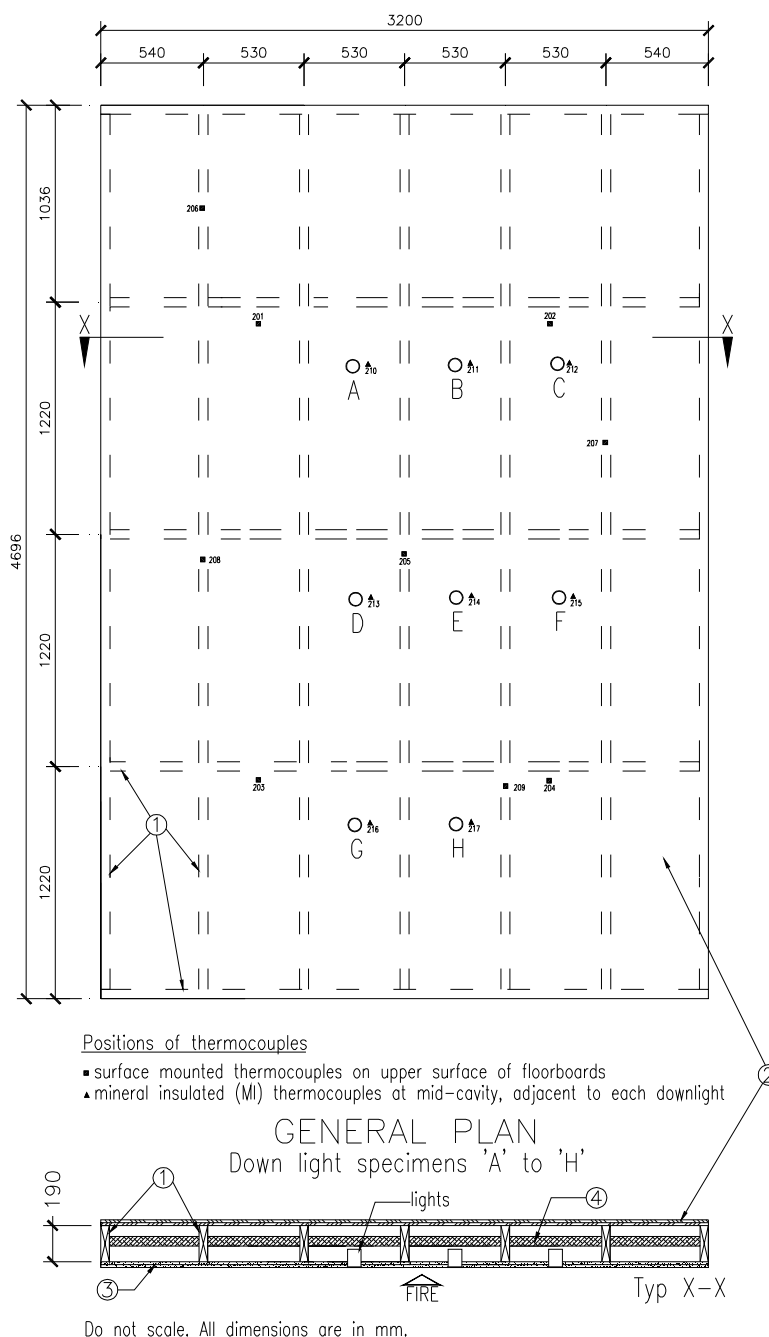
Figure 1 - Specimen General Plan

Thermocouples were provided to monitor the unexposed surface of the floor assembly and the output of all instrumentation was recorded at no less than one minute intervals. The locations and reference numbers of the various unexposed surface and internal thermocouples are shown in Figure 1.

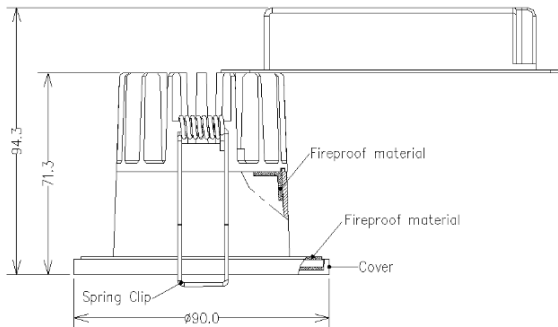
Figure 2 – Details of type No.: FR1137W

5.Specimen 'A'

Type : Round, fix down light

Overall dimensions and construction : See figure 2

Hole size in ceiling boards : 70mm

Materials :
i: cover: Die cast aluminium
ii: spring clip: Spring steel wire, nickel plated

Details of fireproof material :
i: Manufacturer: Dongguan Fumei electronic materials Co., Ltd.
ii: Type: 90minutes fire resistance
iii:Thickness:1.5mm
iv: Location: Strip fitted external around flange of cover

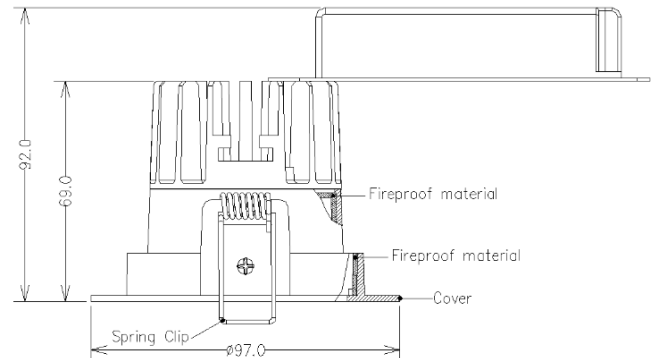
Figure 3 – Details of type No.: FR1175W

6. Specimen 'B'

Type : Round, adjustable down light

Overall dimensions and construction : See figure 3

Hole size in ceiling boards : 83mm

Materials :
i: cover: Die cast aluminium
ii: spring clip: Spring steel wire, nickel plated

Details of fireproof material :
i: Manufacturer: Dongguan Fumei electronic materials Co., Ltd.
ii: Type: 90minutes fire resistance
iii:Thickness:1.5mm
iv: Location: Strip fitted external around flange of cover

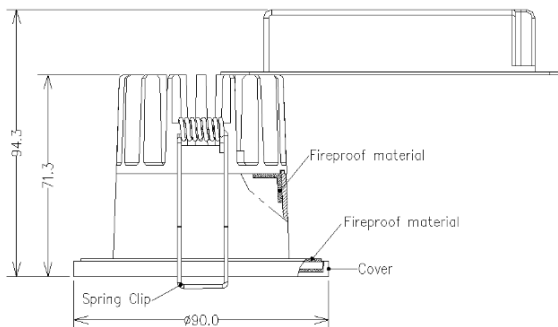
Figure 4 – Details of type No.: FR1185W

7. Specimen 'C'

Product Name : Fire rate Downlight
 Manufacturer :
 Type No. : FR1185W
 Type : Round, fix down light
 Overall dimensions and construction : See figure 4
 Hole size in ceiling boards : 70mm
 Materials :
 i: cover: Die cast aluminium
 ii: spring clip: Spring steel wire, nickel plated
 Approx weight : 0.35kg
 Details of fireproof material :
 i: Manufacturer: Dongguan Fumei electronic materials Co., Ltd.
 ii: Type: 90minutes fire resistance
 iii: Thickness: 1.5mm
 iv: Location: Strip fitted external around flange of cover

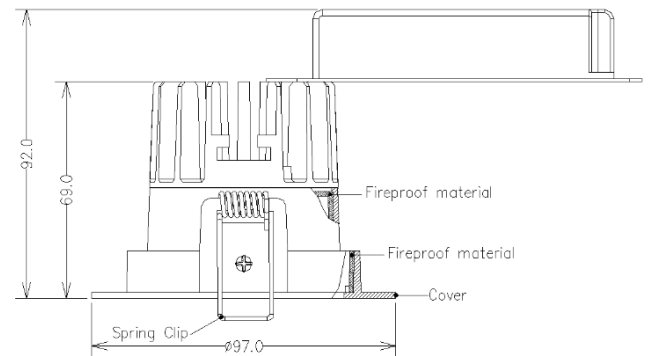
Figure 5 – Details of type No.: FR1193W

8. Specimen 'D'

Product Name : Fire rate Downlight
 Manufacturer :
 Type No. : FR1193W
 Type : Round, adjustable down light
 Overall dimensions and construction : See figure 5
 Hole size in ceiling boards : 83mm
 Materials :
 i: cover: Die cast aluminium
 ii: spring clip: Spring steel wire, nickel plated
 Approx weight : 0.36kg
 Details of fireproof material :
 i: Manufacturer: Dongguan Fumei electronic materials Co., Ltd.
 ii: Type: 90minutes fire resistance
 iii: Thickness: 1.5mm
 iv: Location: Strip fitted external around flange of cover

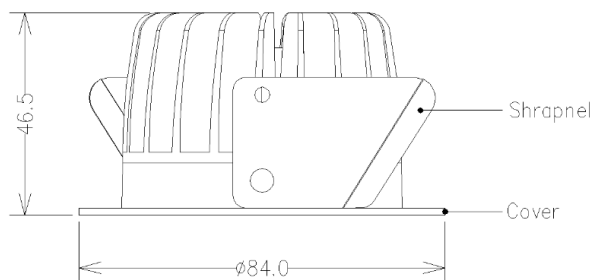
Figure 6 – Details of type No.: FR1001W

9. Specimen 'E'

Product Name : Fire rate Downlight
 Manufacturer :
 Type No. : FR1001W
 Type : Round, fix down light
 Overall dimensions and construction : See figure 6
 Hole size in ceiling boards : 70mm
 Materials :
 i: cover: Die cast aluminium
 ii: shrapnel: Stainless steel
 Approx weight : 0.2kg
 Details of fireproof material :
 i: Manufacturer: Dongguan Fumei electronic materials Co., Ltd.
 ii: Type: 90minutes fire resistance
 iii: Thickness: 1.5mm
 iv: Location: Strip fitted external around flange of cover

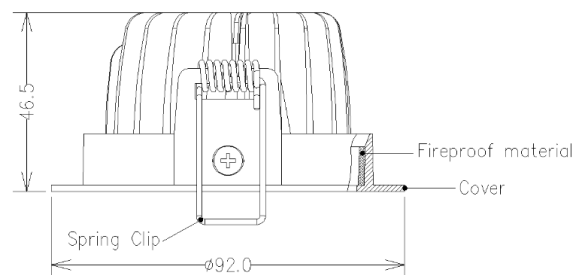
Figure 7 – Details of type No.: FR1003W

10. Specimen 'F'

Product Name : Fire rate Downlight
 Manufacturer :
 Type No. : FR1003W
 Type : Round, adjustable down light
 Overall dimensions and construction : See figure 7
 Hole size in ceiling boards : 83mm
 Materials :
 i: cover: Die cast aluminium
 ii: spring clip: Spring steel wire, nickel plated
 Approx weight : 0.21kg
 Details of fireproof material :
 i: Manufacturer: Dongguan Fumei electronic materials Co., Ltd.
 ii: Type: 90minutes fire resistance
 iii: Thickness: 1.5mm
 iv: Location: Strip fitted external around flange of cover

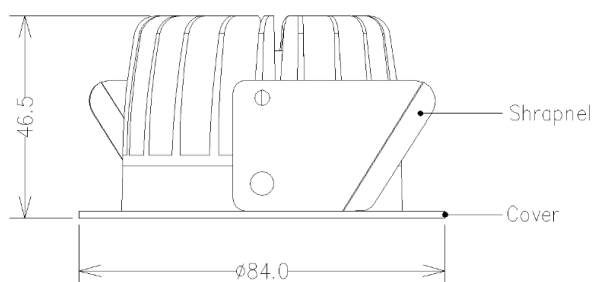
Figure 8 – Details of type No.: FR1009W

11. Specimen 'G'

Product Name : Fire rate Downlight
 Manufacturer
 Type No. : FR1009W
 Type : Round, fix down light
 Overall dimensions and construction : See figure 8
 Hole size in ceiling boards : 70mm
 Materials :
 i: cover: Die cast aluminium
 ii: shrapnel: Stainless steel
 Approx weight : 0.2kg
 Details of fireproof material :
 i: Manufacturer: Dongguan Fumei electronic materials Co., Ltd.
 ii: Type: 90 minutes fire resistance
 iii: Thickness: 1.5mm
 iv: Location: Strip fitted external around flange of cover

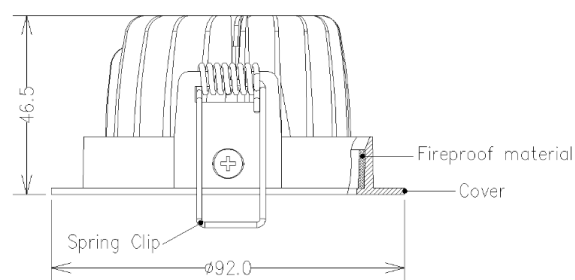
Figure 9 – Details of type No.: FR1011W

12. Specimen 'H'

Product Name : Fire rate Downlight
 Manufacturer
 Type No. : FR1011W
 Type : Round, adjustable down light
 Overall dimensions and construction : See figure 9
 Hole size in ceiling boards : 83mm
 Materials :
 i: cover: Die cast aluminium
 ii: spring clip: Spring steel wire, nickel plated
 Approx weight : 0.21kg
 Details of fireproof material :
 i: Manufacturer: Dongguan Fumei electronic materials Co., Ltd.
 ii: Type: 90 minutes fire resistance
 iii: Thickness: 1.5mm
 iv: Location: Strip fitted external around flange of cover

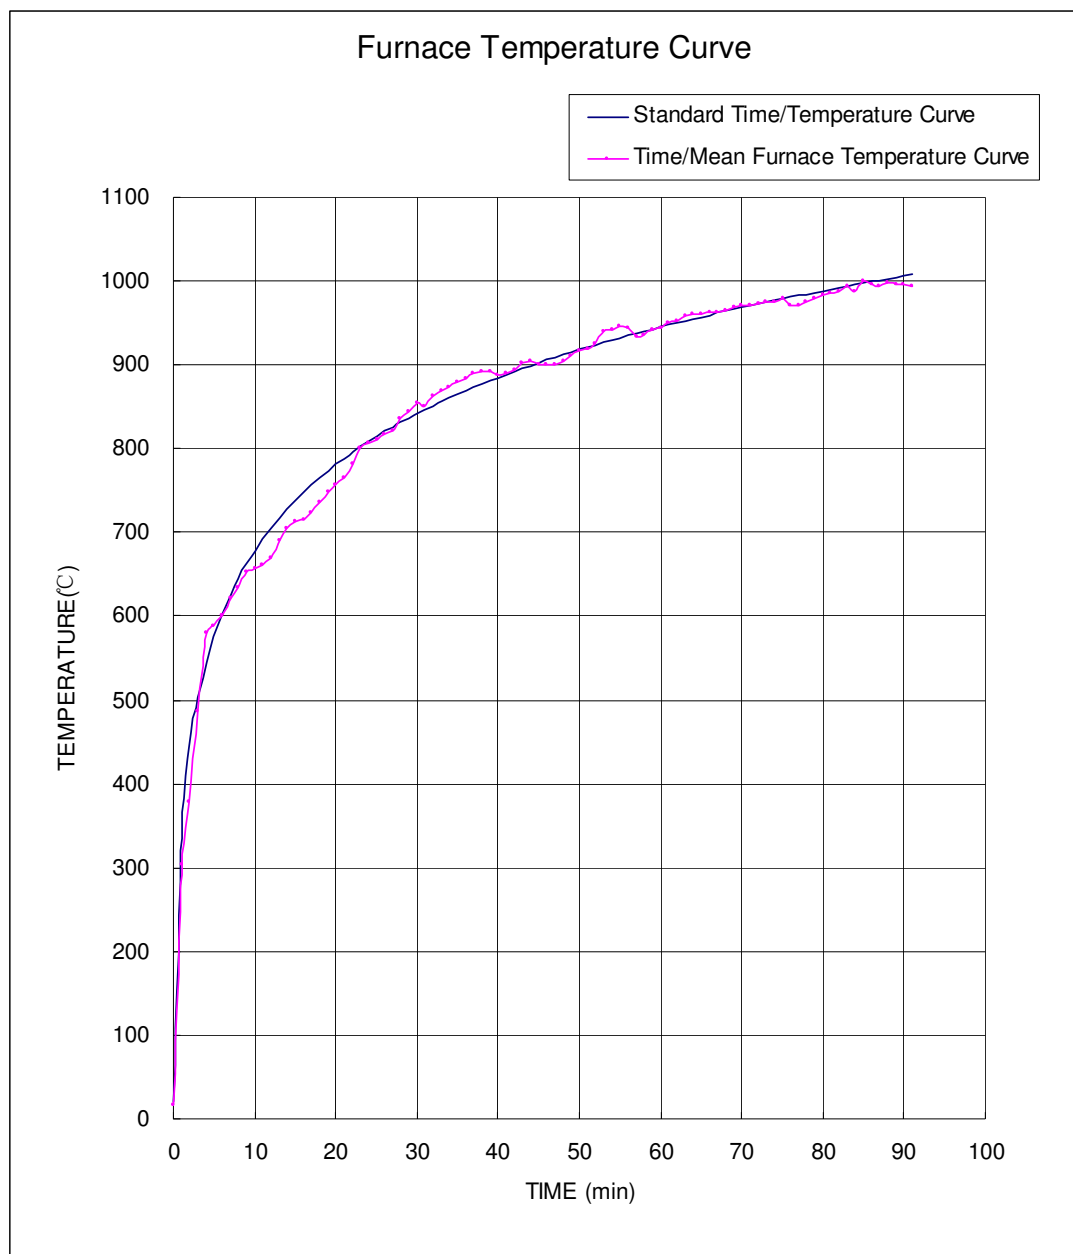
Appendix 3 - Furnace Temperature Curve

The furnace temperature was measured by means of eight thermocouples distributed evenly in the furnace, with their measuring junctions 100 mm ± 10 mm from the exposed surface of the specimen. The furnace was controlled so that the mean of the eight thermocouple readings followed as closely as possible the time/temperature relationship specified in Clause 3.1 of BS 476-20:1987.

The mean furnace temperature records are shown in Appendix 6, and the actual time-temperature curve of furnace in relation to the specified time-temperature curve is shown in Appendix 3.

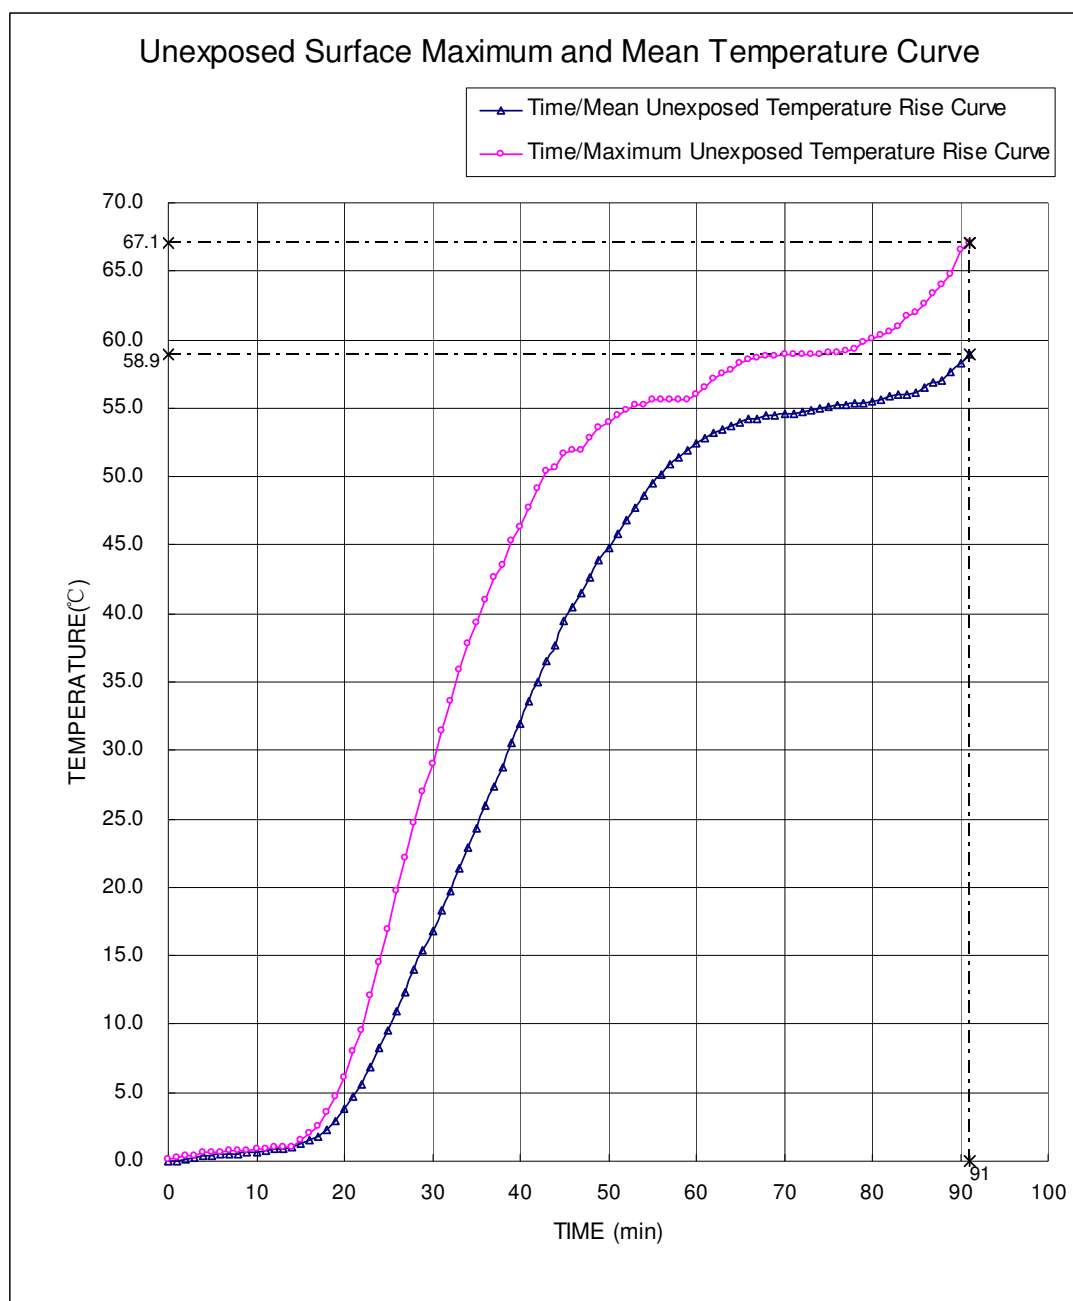
Appendix 4 - Unexposed Face Mean and Maximum Temperature Curve

The unexposed surface temperature records are shown in Appendix 7, and the individual temperatures recorded adjacent to the downlight fittings at mid-height of the cavity are shown in Appendix 8. The unexposed surface maximum and mean temperature curve are shown in Appendix 4.

- a) When the mean unexposed face temperature increases by more than 140°C above its initial value;
- b) When the temperature recorded at any positions on the unexposed face is in excess of 180°C above the initial mean unexposed face temperature;
- c) When integrity failure occurs

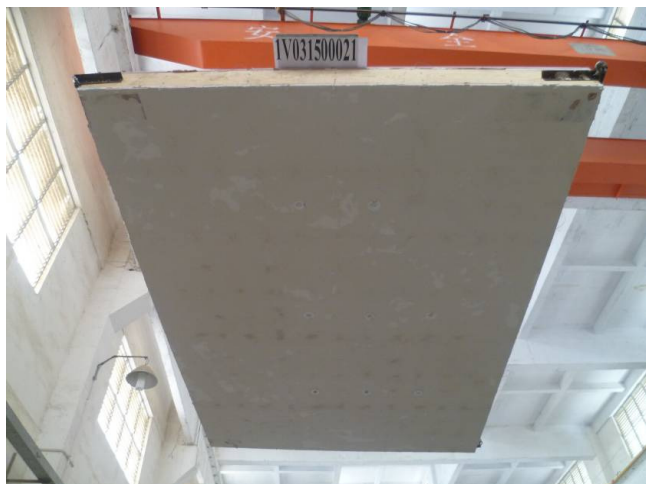
Photo 17: The exposed surface of the specimen before the test

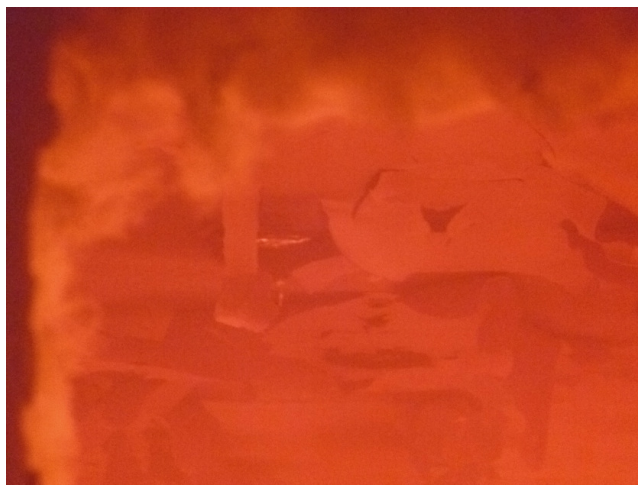
Photo 20: The exposed surface of the specimen after a test duration of 24 minutes, showing the specimen 'A' fused.

| Time (min) | Observation (All observations are from the exposed face unless noted otherwise) |
|---|--|
| 24 | Specimen 'A' fused. |

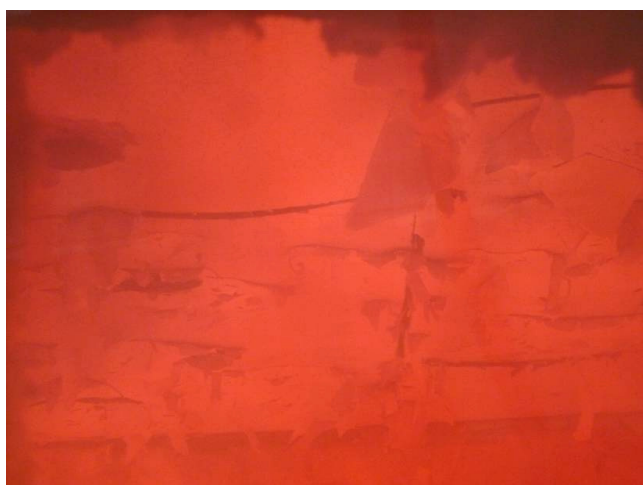
Photo 23: The exposed surface of the specimen after a test duration of 48 minutes, showing the specimen 'D' and 'E' fell away and the nearby first layer of plasterboard ceiling started to sag slightly and joints began to open.

| Time (min) | Observation (All observations are from the exposed face unless noted otherwise) |
|---|--|
| 40 | The first layer of plasterboard ceiling started to sag slightly and joints began to open. |
| 48 | Specimen 'D' and 'E' fell away. |

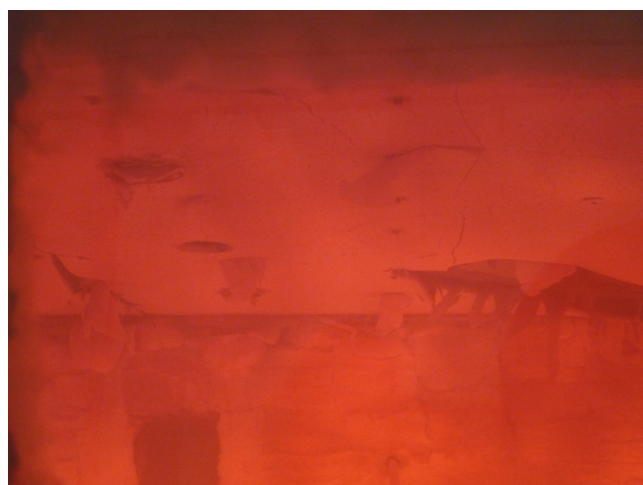
Photo 24: The exposed surface of the specimen after a test duration of 54 minutes, showing the specimen 'B' and 'C' fell away and a part of first layer of plasterboard ceiling fell away.

| Time (min) | Observation (All observations are from the exposed face unless noted otherwise) |
|---|--|
| 52 | Specimen 'B', 'C' and 'H' fell away. |
| 54 | The first layer of plasterboard ceiling between specimen 'H' and 'F' fell away, and the specimen 'F' fell away at the same time. |

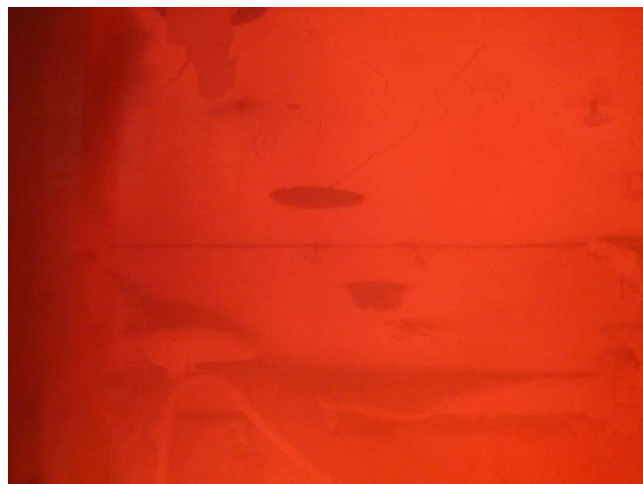
Photo 26: The exposed surface of the specimen after a test duration of 68 minutes, showing cracks appeared on second layer of plasterboard ceiling.

| Time (min) | Observation (All observations are from the exposed face unless noted otherwise) |
|---|--|
| 68 | Some cracks appeared on second layer of plasterboard ceiling. |

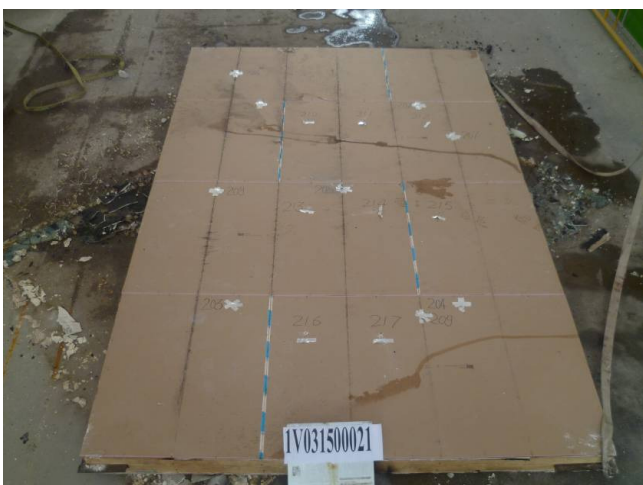
Photo 28: The unexposed surface of the specimen after the test
